SIO Shipyard Representative Bi-Weekly Progress Report		
Project: AGOR 28	Contract No.: N00014-12-C-0305	Shipyard: Dakota Creek Industries
Prepared by: Paul D. Bueren Scripps Institution of Oceanography (SIO) 297 Rosecrans St. San Diego, CA 98106	Date: 1 March 2016	Program Officer: Robert (Tim) Schnoor Office of Naval Research 875 Randolph St ONR 321 Arlington, VA 22203-1995
Distribution Statement A: Approved for public release; distribution unlimited.		Report No. A002.095

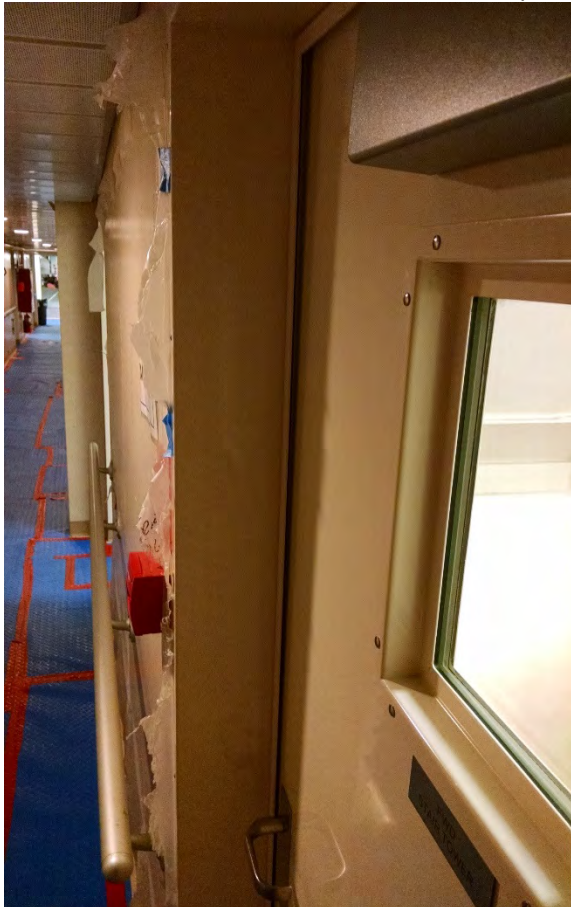
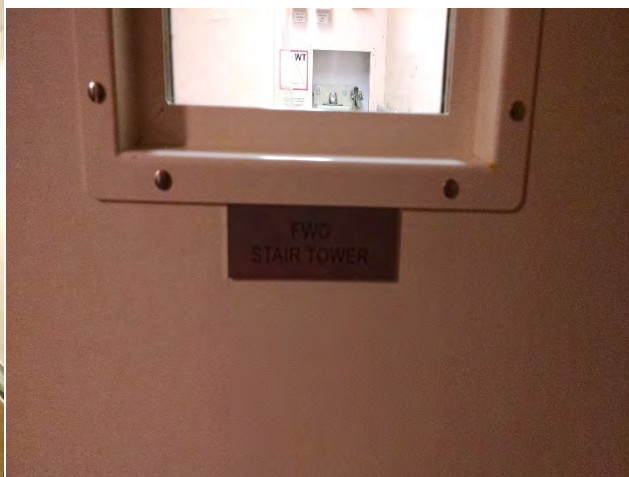
Bad Access door main deck to fwd stair tower sprung. Difficult to operate, will point out to DCI.

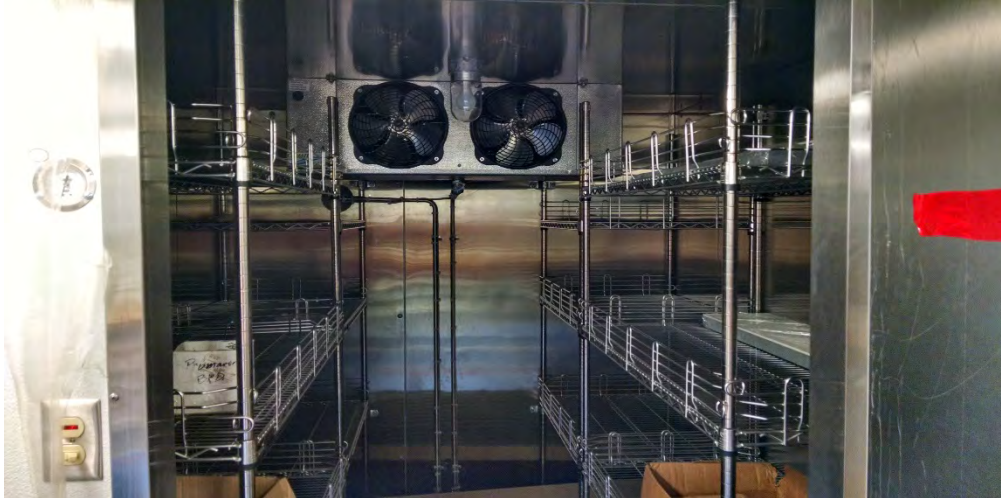
Science Refer crew training instructor from Bronswerk mentioned that the strip heaters on the condensate drains in the science boxes are possibly too large. Boxes are quite warm with refrigeration secured. Will

bring it up to the shipyard.

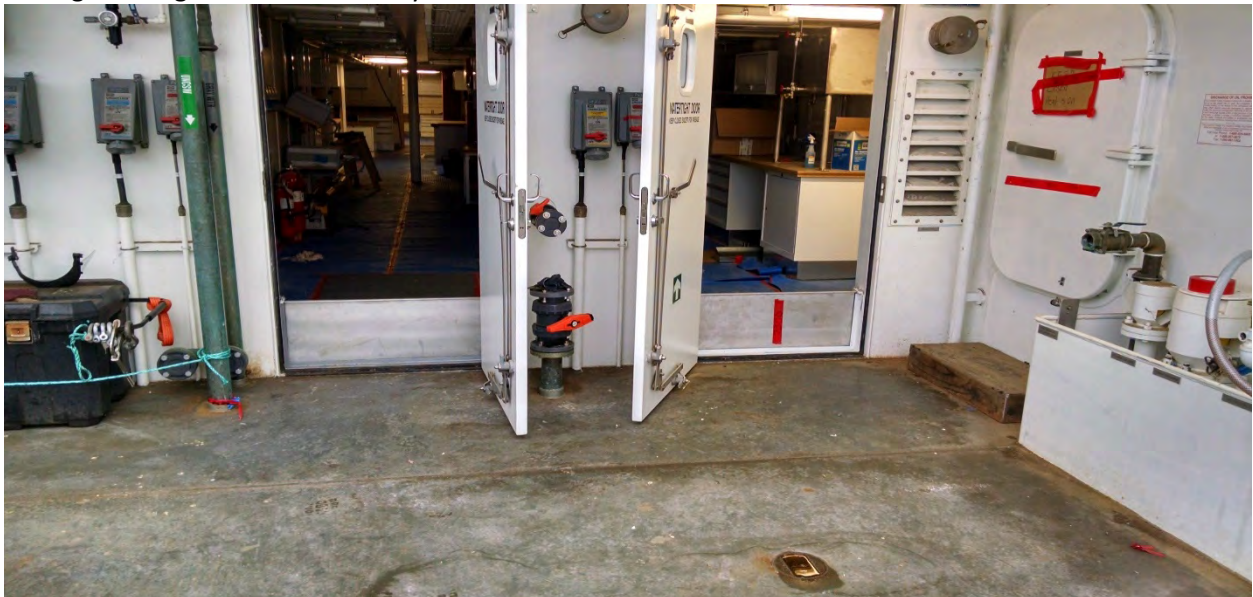
DCI was shown first-hand the need for raised sills on main deck hatches. During Trials last week boarding seas made it into the labs. There was a flurry of activity as the sills were located and installed. No damage but a good lesson for the yard workers.

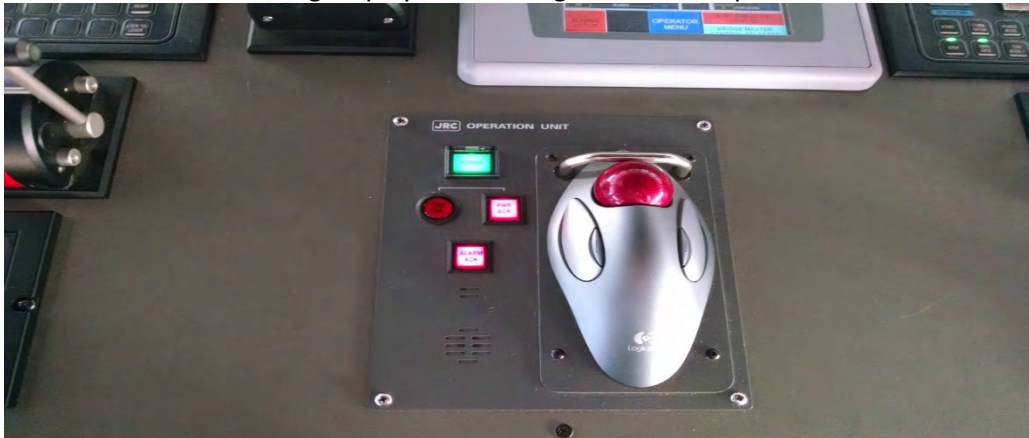
Mouse control for the Conning Display on the bridge console not provided with dimmer.

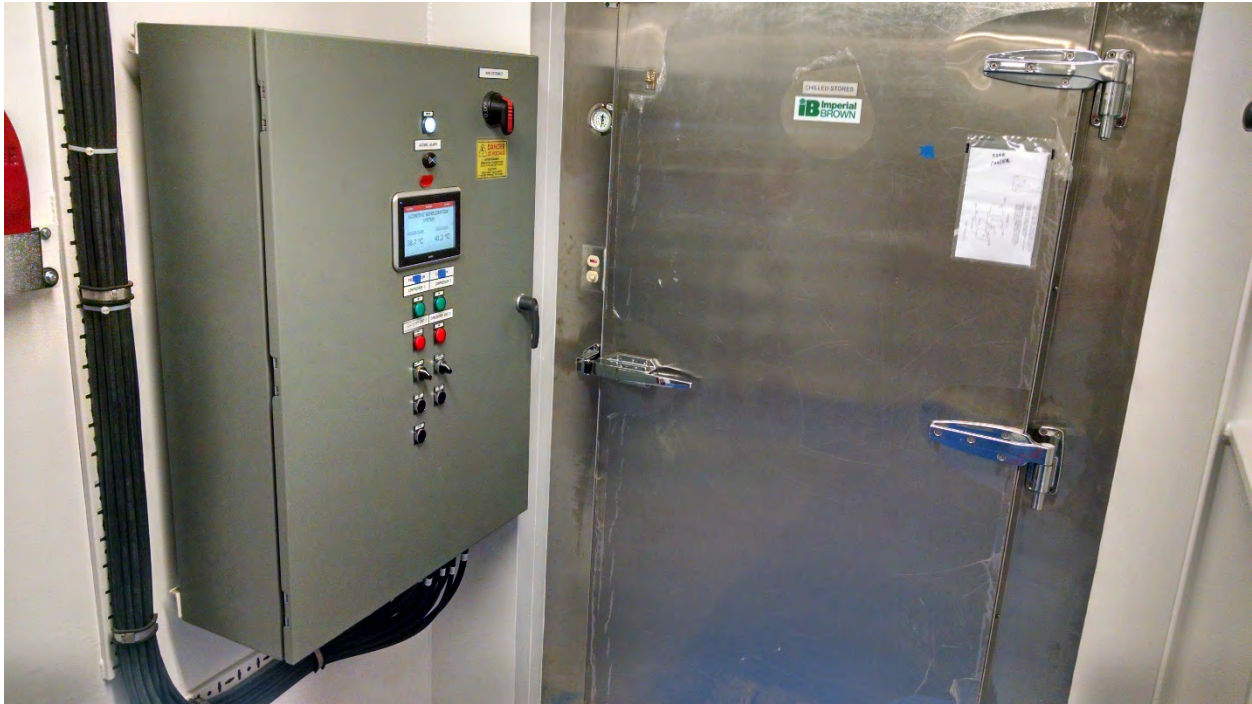
Science Refer controller installed adjacent to the ships stores Chill Box. This location is unfortunate potentially confusing for operators and in the way when loading stores. Will investigate relocating Science refer controller.

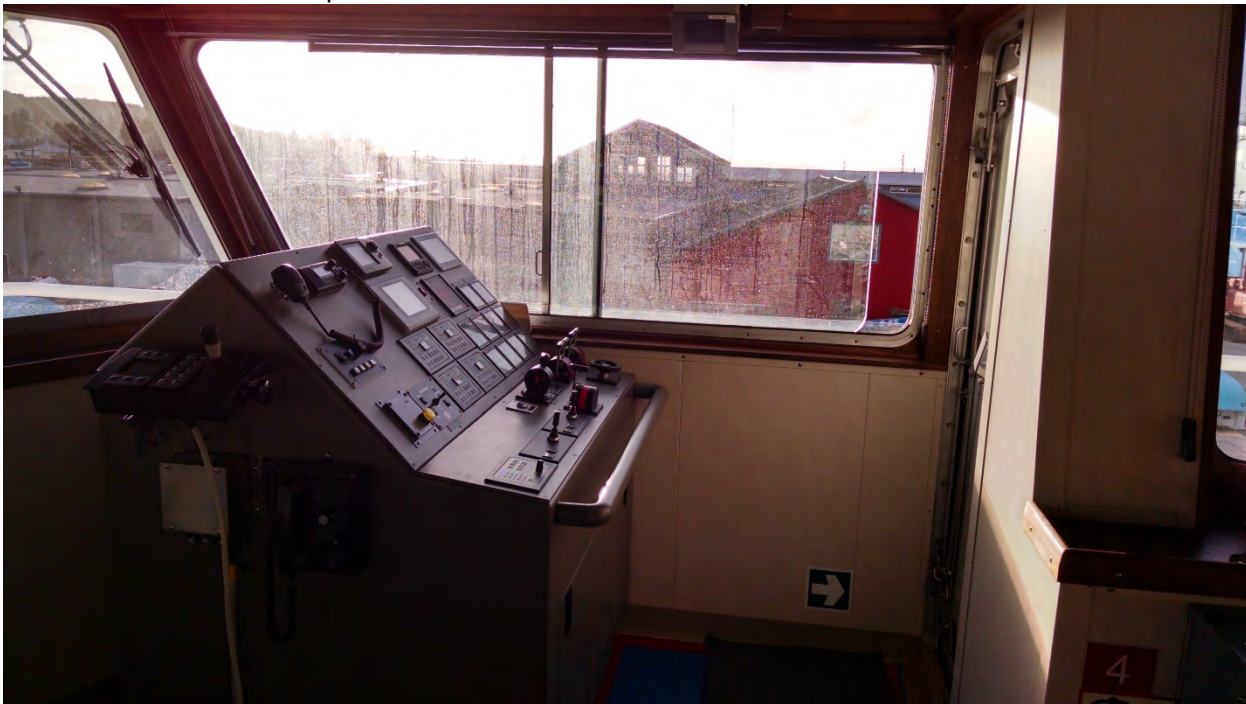
Bridge side windows pretty tough to clean. Not served with the wash down system. After sliding glass covers forward when opened

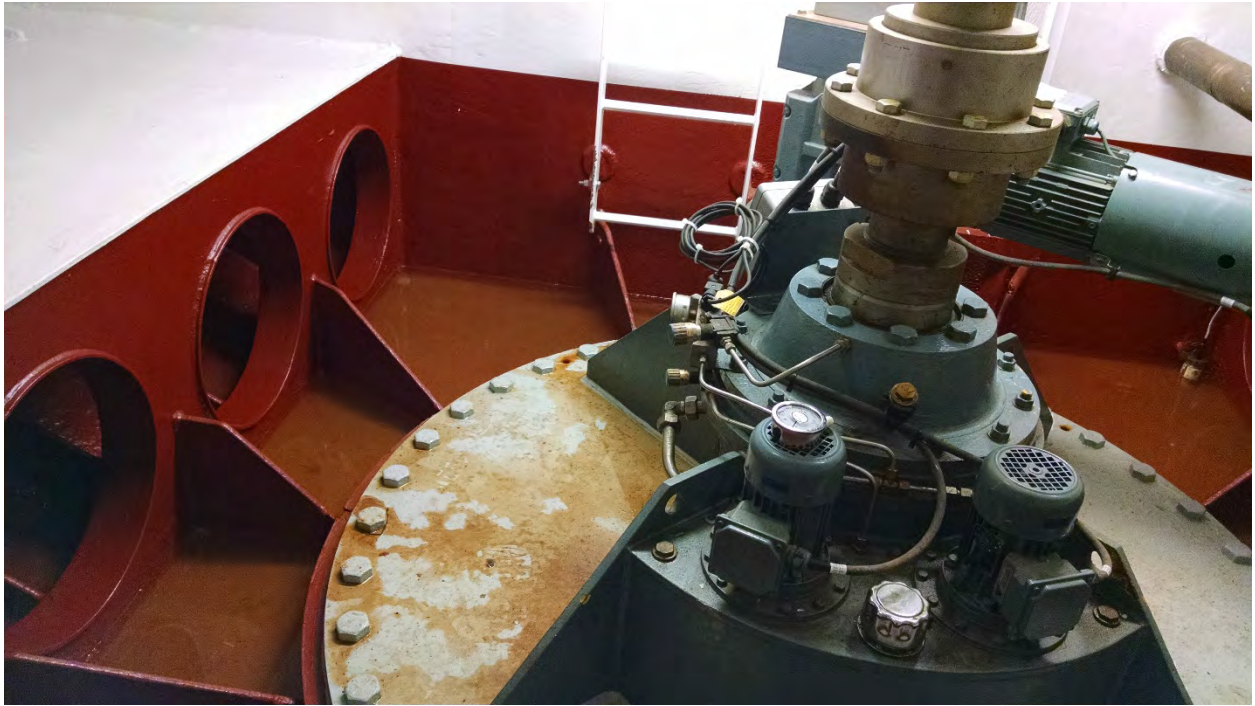
Bow thruster bilge, designed in leakage for shaft cooling. Bilges look like this today

Note: Yard has since cleaned and dewatered the space. Pb.
